**Flood Control Project Maintenance  
Levee Inspections**

**Fall 2013 Levee Maintenance Deficiency Summary Report**

**San Joaquin River Basin**

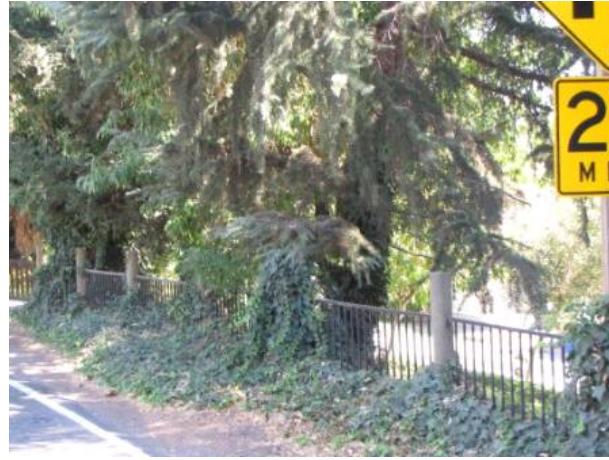
Levee Mile Report Line	191
Start Levee Mile	22.17
End Levee Mile	22.18
Location	Land Side
Category	Earthen Levee
Item	Encroachments
View of a fence and landscaping along the landward shoulder and slope looking upstream.	
pkazi_f_20131001_466.jpg

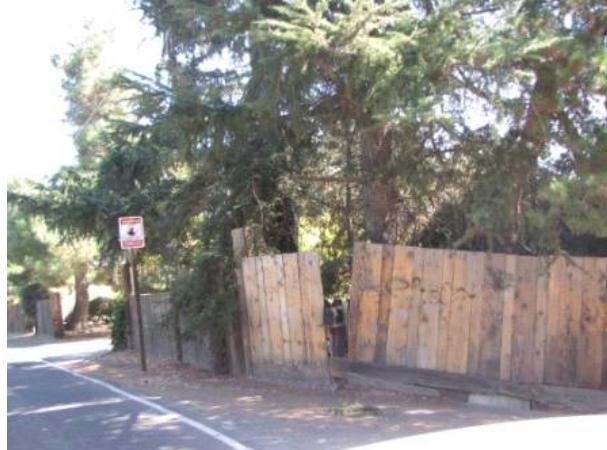
Levee Mile Report Line	192
Start Levee Mile	22.19
End Levee Mile	22.21
Location	Land Side
Category	Earthen Levee
Item	Encroachments
View of a fence along the landward shoulder and slope looking upstream.	
pkazi_f_20131001_465.jpg

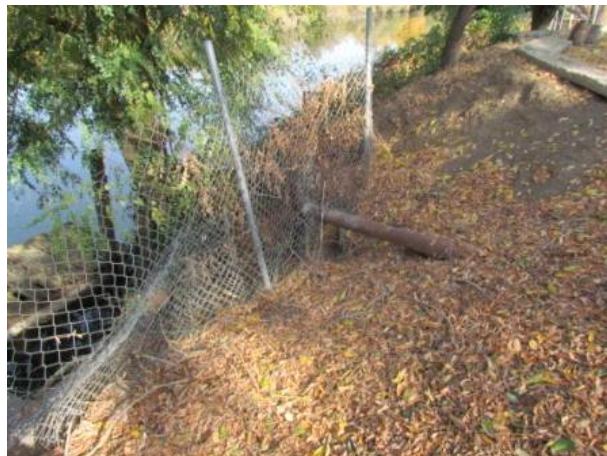
Levee Mile Report Line	194
Start Levee Mile	22.21
End Levee Mile	22.21
Location	Water Side
Category	Earthen Levee
Item	Encroachments
An unpermitted abandoned pipe was found with electrical wires running through it on the waterside shoulder of the levee looking upstream.	
pkazi_f_20131001_458.jpg

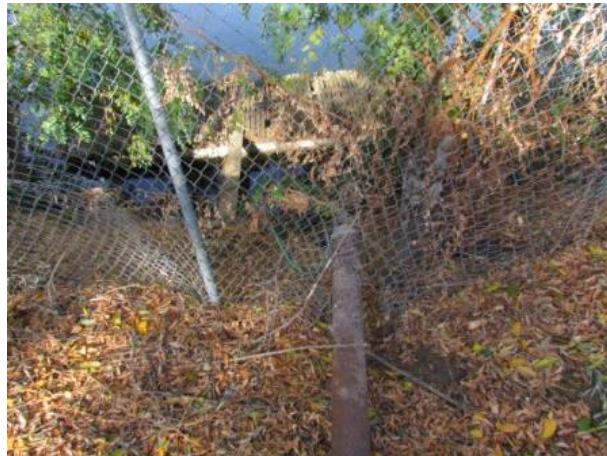
Levee Mile Report Line	194
Start Levee Mile	22.21
End Levee Mile	22.21
Location	Water Side
Category	Earthen Levee
Item	Encroachments
View of the electrical wires through the pipe is found on the waterside of the levee. The picture was taken from the crown looking towards the toe of the levee.	
pkazi_f_20131001_459.jpg

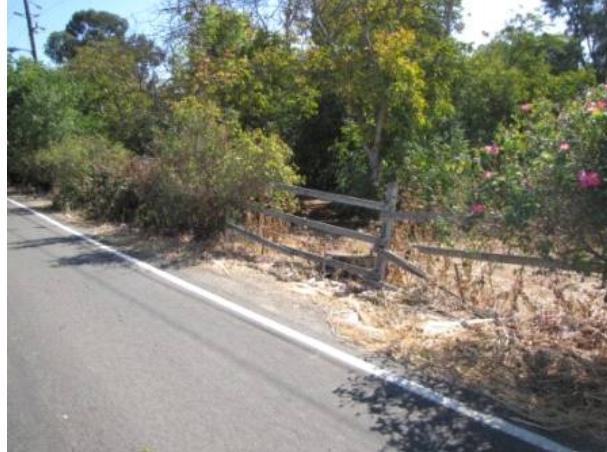
Levee Mile Report Line	195
Start Levee Mile	22.26
End Levee Mile	22.30
Location	Land Side
Category	Earthen Levee
Item	Encroachments
View of a fence along the landward shoulder looking upstream.	
<i>pkazi_f_20131001_464.jpg</i>

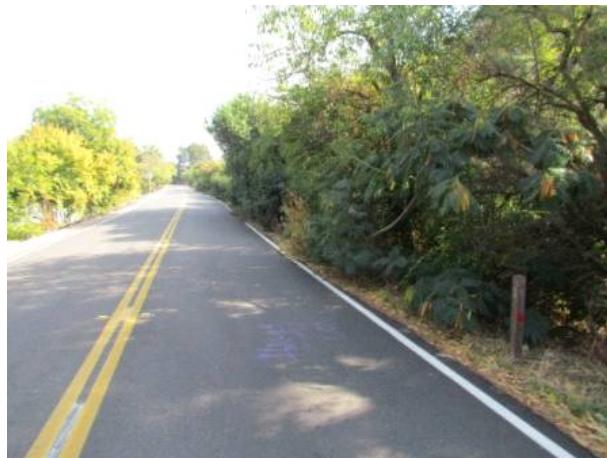
Levee Mile Report Line	196
Start Levee Mile	22.27
End Levee Mile	22.28
Location	Land Side
Category	Earthen Levee
Item	Vegetation
Landscaping was found on the landside of the levee looking upstream.	
<i>pkazi_f_20131001_429.jpg</i>

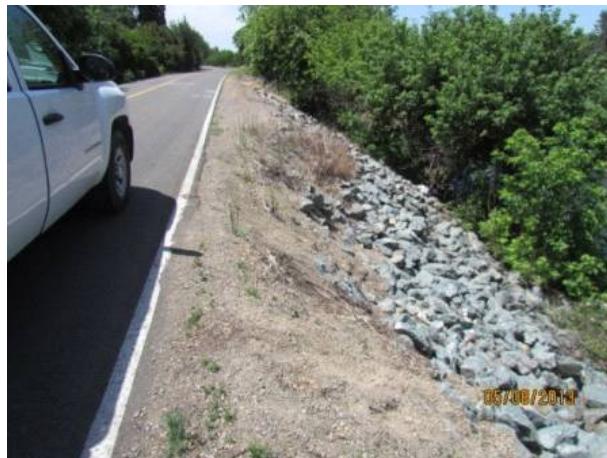
Levee Mile Report Line	197
Start Levee Mile	22.30
End Levee Mile	22.30
Location	Water Side
Category	Earthen Levee
Item	Slope Stability
Slope instability was found on the waterside slope of the levee looking downstream.	
<i>pkazi_f_20131001_514.JPG</i>

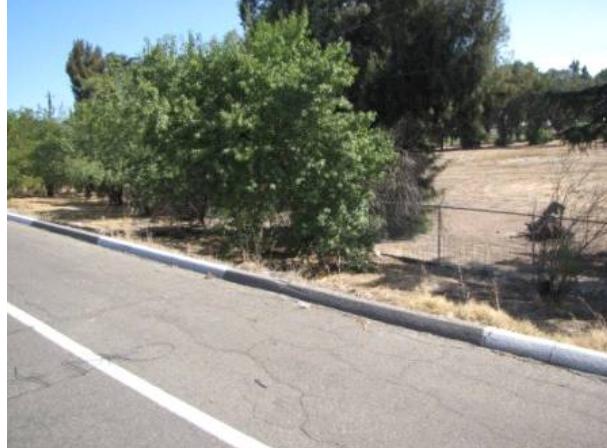
Levee Mile Report Line	198
Start Levee Mile	22.37
End Levee Mile	22.43
Location	Land Side
Category	Earthen Levee
Item	Encroachments
View of fence and landscaping along landward slope looking upstream.	
pkazi_f_20131001_461.jpg

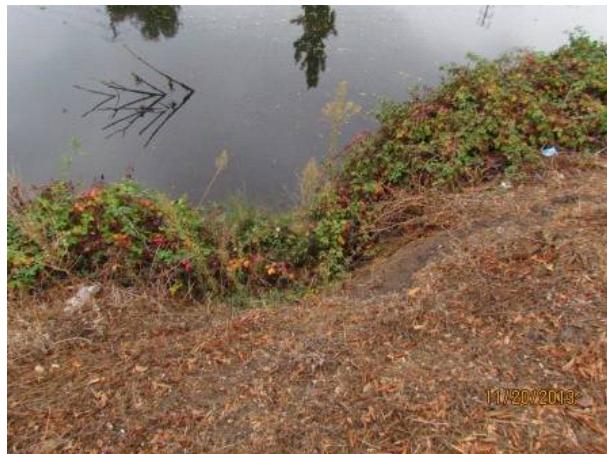
Levee Mile Report Line	199
Start Levee Mile	22.41
End Levee Mile	22.41
Location	Water Side
Category	Earthen Levee
Item	Erosion / Bank Caving
Erosion was found on the waterside slope of the levee looking upstream.	
pkazi_f_20131122_073.JPG

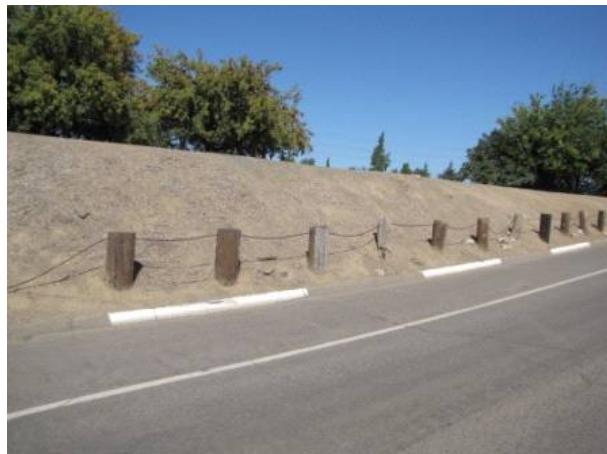
Levee Mile Report Line	200
Start Levee Mile	22.43
End Levee Mile	22.46
Location	Land Side
Category	Earthen Levee
Item	Encroachments
View of a post and cable fence along the landward slope looking upstream.	
pkazi_f_20131001_460.jpg

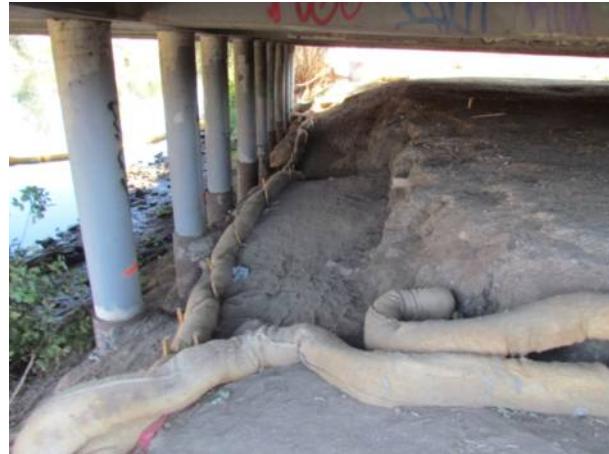
Levee Mile Report Line	201
Start Levee Mile	22.52
End Levee Mile	22.52
Location	Water Side
Category	Earthen Levee
Item	Erosion / Bank Caving
View of the erosion under the I-5 bridge looking upstream.	
pkazi_f_20131001_414.jpg

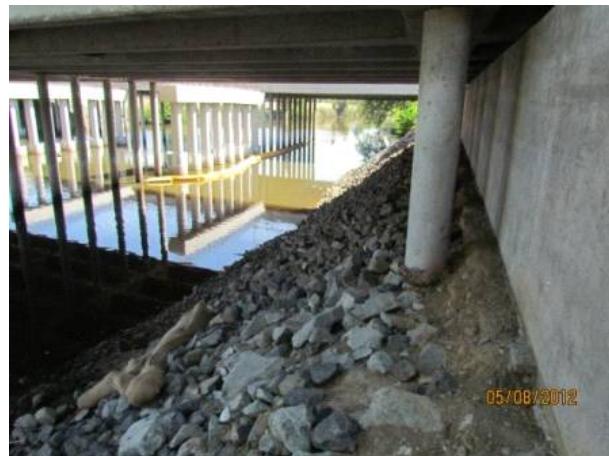
Levee Mile Report Line	201
Start Levee Mile	22.52
End Levee Mile	22.52
Location	Water Side
Category	Earthen Levee
Item	Erosion / Bank Caving
View of the erosion site repaired by Caltrans under the I-5 freeway going southbound. This picture was taken from the toe of the levee looking upstream.	
pkazi_f_20131001_415.jpg

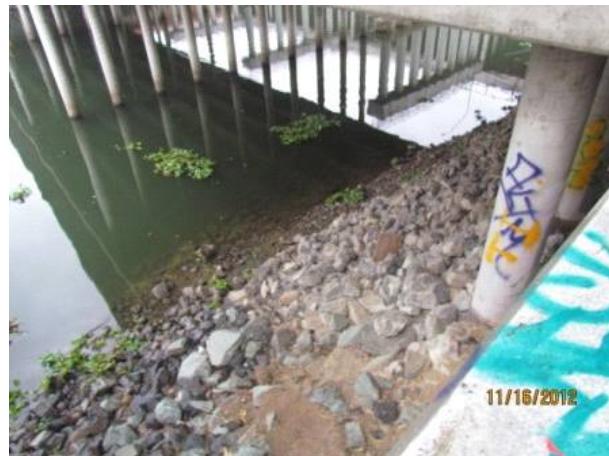
Levee Mile Report Line	201
Start Levee Mile	22.52
End Levee Mile	22.52
Location	Water Side
Category	Earthen Levee
Item	Erosion / Bank Caving
Updated view of the erosion site repaired by Caltrans on the waterside slope of the levee looking upstream.	
pkazi_f_20131001_416.jpg

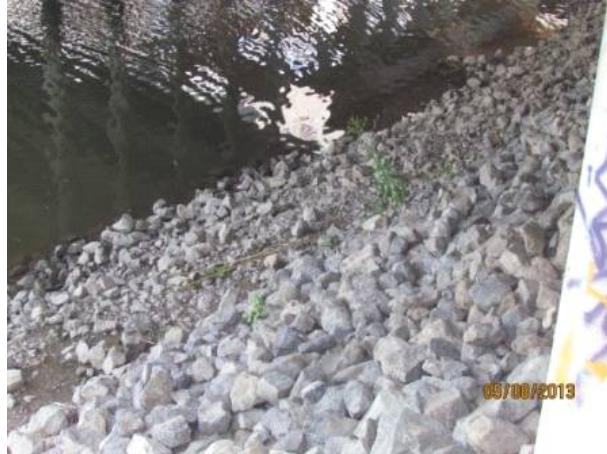
Levee Mile Report Line	201
Start Levee Mile	22.52
End Levee Mile	22.52
Location	Water Side
Category	Earthen Levee
Item	Erosion / Bank Caving
Updated view of the erosion site over the I-5 bridge (southbound) repaired by Caltrans. This picture was taken from the crown of the levee looking upstream during spring 2013 inspection.	
pkazi_f_20131001_417.JPG

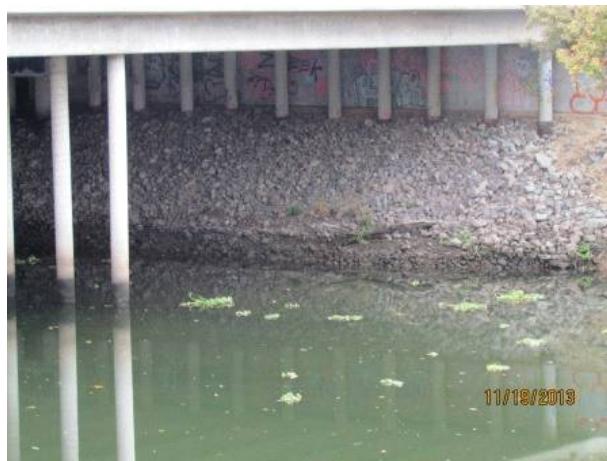
Levee Mile Report Line	201
Start Levee Mile	22.52
End Levee Mile	22.52
Location	Water Side
Category	Earthen Levee
Item	Erosion / Bank Caving
Updated picture of erosion was found on the waterside toe of the levee looking from the opposite side of the levee.	
pkazi_f_20131120_070.JPG

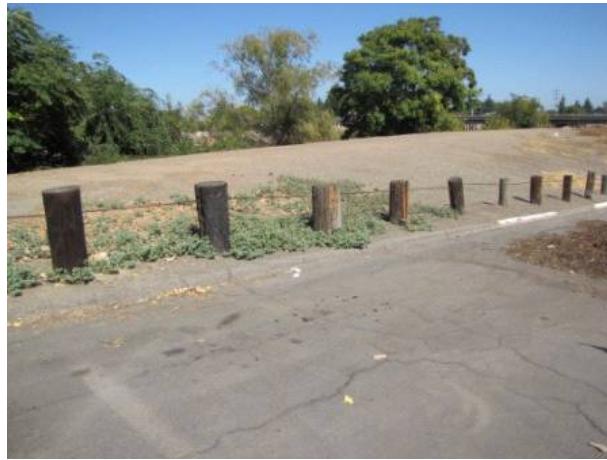
Levee Mile Report Line	202
Start Levee Mile	22.52
End Levee Mile	22.57
Location	Land Side
Category	Earthen Levee
Item	Encroachments
View of post and cable fence along the landward levee slope looking upstream.	
pkazi_f_20131001_457.jpg

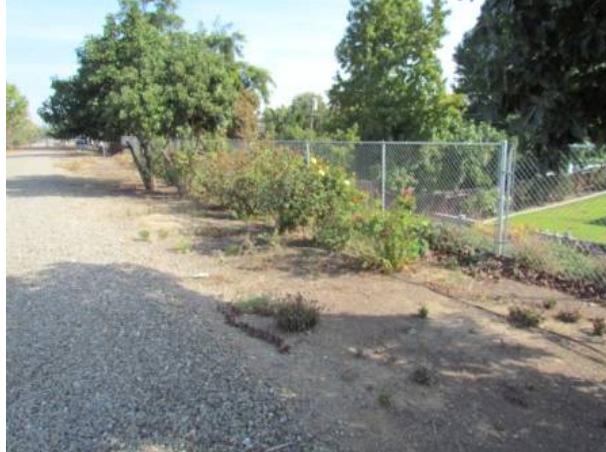
Levee Mile Report Line	203
Start Levee Mile	22.58
End Levee Mile	22.87
Location	Land Side
Category	Earthen Levee
Item	Vegetation
Landscape was found on the landside of the levee looking upstream.	
pkazi_f_20131001_455.jpg

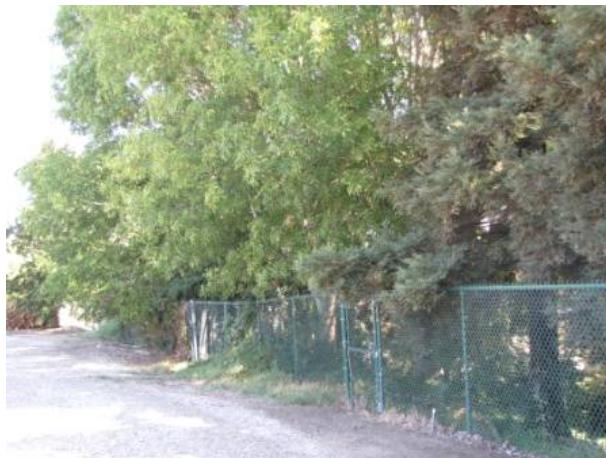
Levee Mile Report Line	204
Start Levee Mile	22.58
End Levee Mile	22.87
Location	Land Side
Category	Earthen Levee
Item	Encroachments
View of fence and landscaping along the landward shoulder and slope looking upstream.	
pkazi_f_20131001_454.jpg

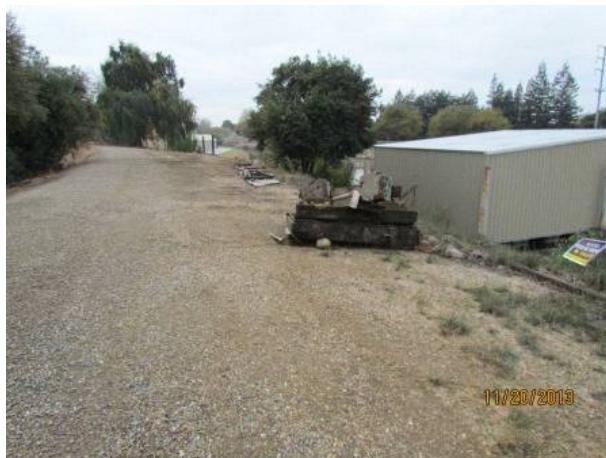
Levee Mile Report Line	205
Start Levee Mile	22.76
End Levee Mile	22.76
Location	Water Side
Category	Earthen Levee
Item	Encroachments
Debris was found on the waterside shoulder of the levee looking downstream.	
pkazi_f_20131122_071.JPG

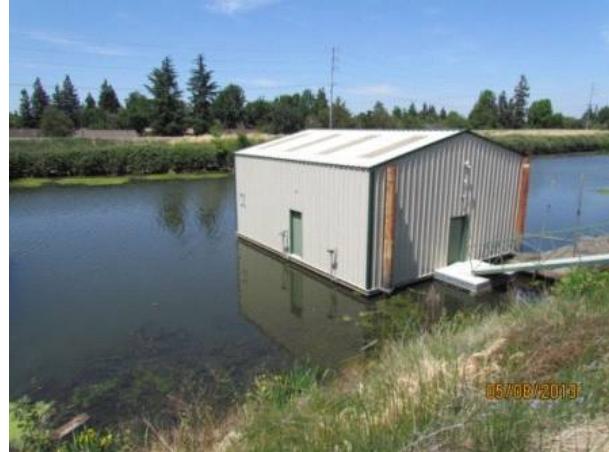
Levee Mile Report Line	206
Start Levee Mile	22.77
End Levee Mile	22.77
Location	Water Side
Category	Earthen Levee
Item	Encroachments
A dock was found on the waterside toe of the levee looking upstream.	
pkazi_f_20131001_515.JPG

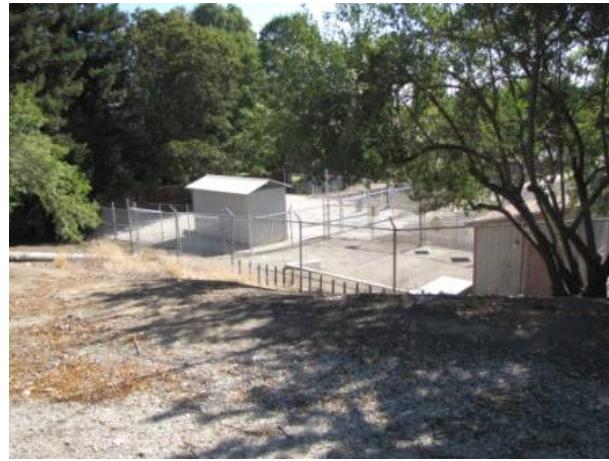
Levee Mile Report Line	207
Start Levee Mile	22.87
End Levee Mile	22.89
Location	Land Side
Category	Earthen Levee
Item	Encroachments
View of fence along the landward slope.	
pkazi_f_20131001_453.jpg

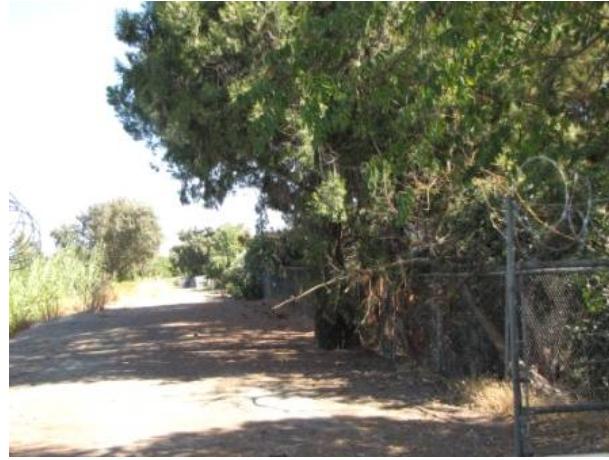
Levee Mile Report Line	210
Start Levee Mile	22.90
End Levee Mile	23.08
Location	Land Side
Category	Earthen Levee
Item	Encroachments
View of fence and landscaping along the landward shoulder looking upstream.	
pkazi_f_20131001_451.jpg

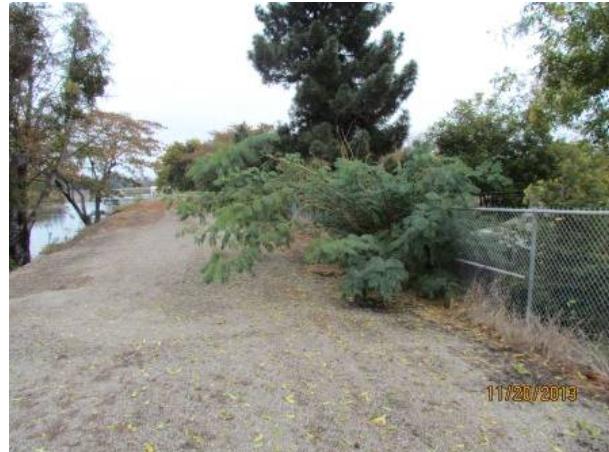
Levee Mile Report Line	211
Start Levee Mile	22.97
End Levee Mile	22.97
Location	Land Side
Category	Earthen Levee
Item	Trim / Thin Trees
Tree limbs were obstructing the crown looking upstream.	
pkazi_f_20131122_072.JPG

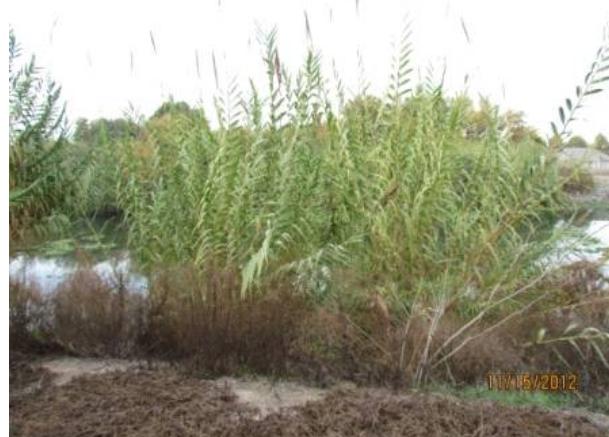
Levee Mile Report Line	212
Start Levee Mile	23.05
End Levee Mile	23.05
Location	Water Side
Category	Earthen Levee
Item	Vegetation
Arundo was found on the waterside slope of the levee looking upstream.	
pkazi_f_20131001_413.jpg

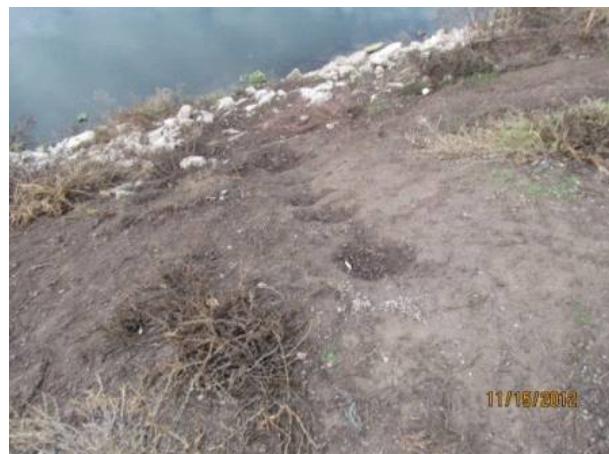
Levee Mile Report Line	213
Start Levee Mile	23.07
End Levee Mile	23.07
Location	Water Side
Category	Earthen Levee
Item	Encroachments
Steps were dug on to the waterside slope of the levee looking upstream.	
pkazi_f_20131001_401.jpg

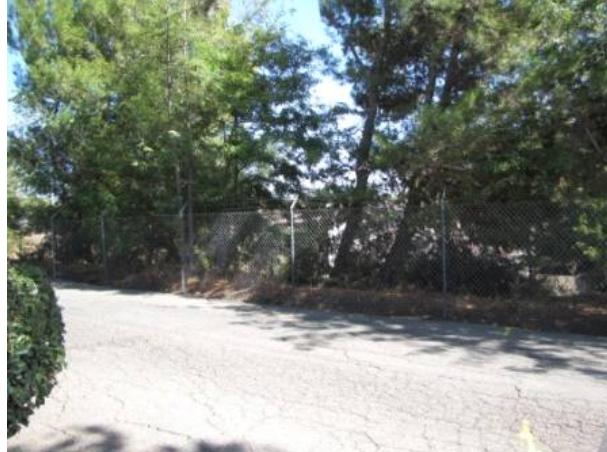
Levee Mile Report Line	214
Start Levee Mile	23.08
End Levee Mile	23.22
Location	Land Side
Category	Earthen Levee
Item	Encroachments
View of fence along the landward shoulder looking upstream.	
<i>pkazi_f_20131001_449.jpg</i>

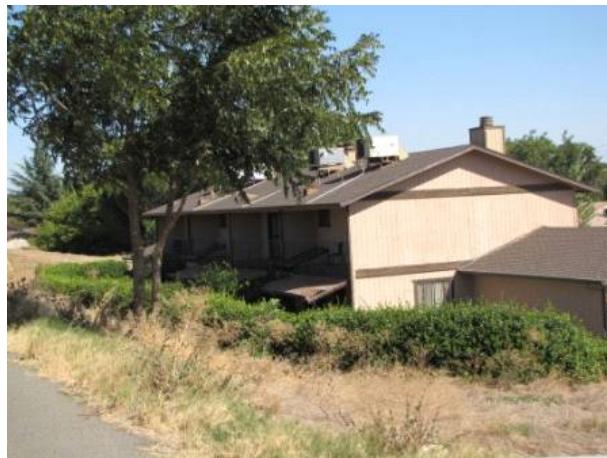
Levee Mile Report Line	215
Start Levee Mile	23.24
End Levee Mile	23.27
Location	Land Side
Category	Earthen Levee
Item	Vegetation
View of landscaping along the landward slope looking upstream.	
<i>pkazi_f_20131001_448.jpg</i>

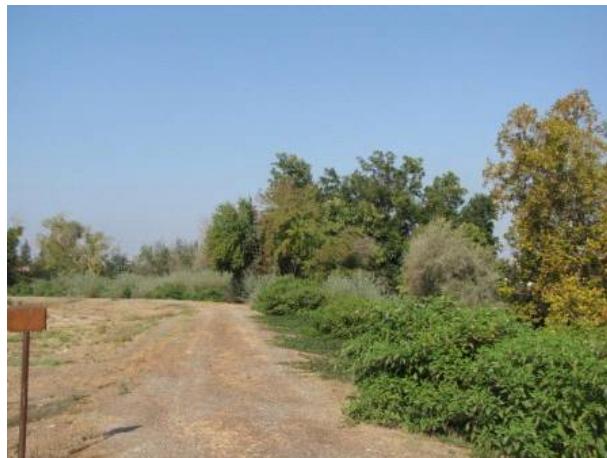
Levee Mile Report Line	218
Start Levee Mile	23.70
End Levee Mile	23.70
Location	Water Side
Category	Earthen Levee
Item	Encroachments
View of vegetation along the waterward slope looking downstream.	
<i>pkazi_f_20131001_506.jpg</i>

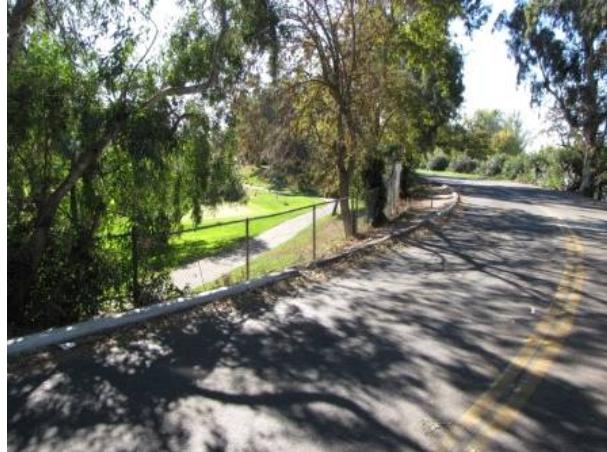
Levee Mile Report Line	220
Start Levee Mile	23.70
End Levee Mile	24.00
Location	Land Side
Category	Earthen Levee
Item	Encroachments
View of the fence along the landward slope looking downstream.	
pkazi_f_20131001_505.jpg

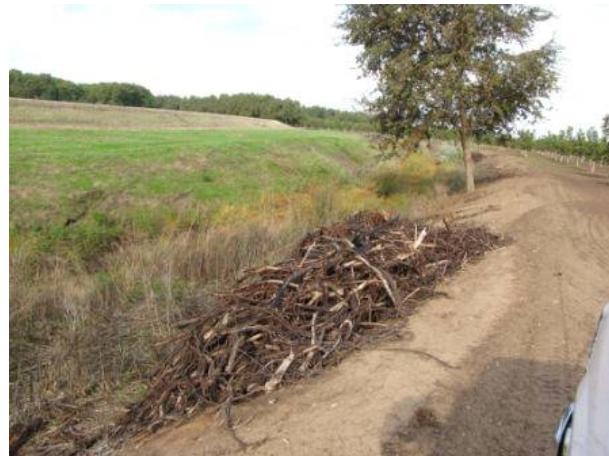
Levee Mile Report Line	1
Start Levee Mile	0.13
End Levee Mile	0.13
Location	Water Side
Category	Earthen Levee
Item	Encroachments
View of a prunings pile along the waterward bank looking downstream.	
<i>pkazi_f_20131001_560.jpg</i>

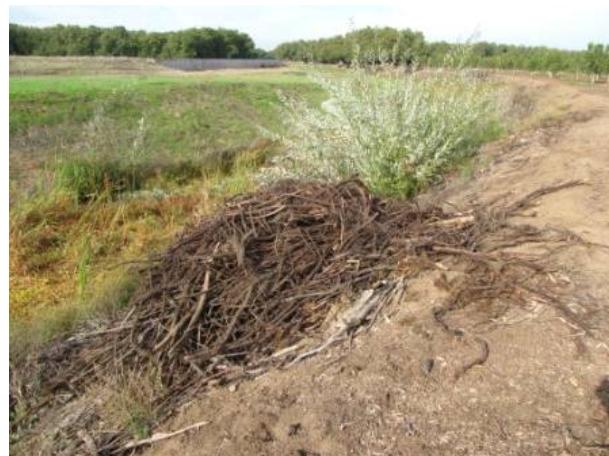
Levee Mile Report Line	2
Start Levee Mile	0.17
End Levee Mile	0.17
Location	Water Side
Category	Earthen Levee
Item	Encroachments
View of a prunings pile along the waterward bank looking downstream.	
<i>pkazi_f_20131001_561.jpg</i>

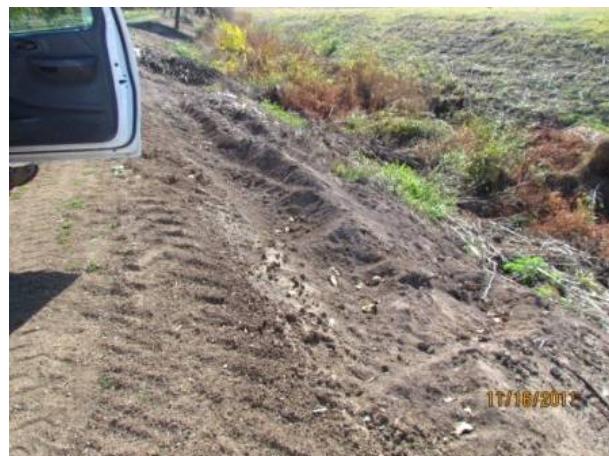
Levee Mile Report Line	3
Start Levee Mile	0.19
End Levee Mile	0.19
Location	Water Side
Category	Earthen Levee
Item	Slope Stability
Slope instability was found on the waterside of the levee looking upstream.	
<i>pkazi_f_20131001_566.jpg</i>

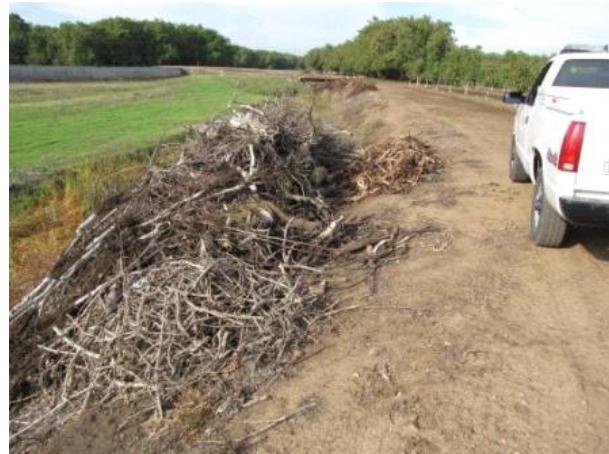
Levee Mile Report Line	4
Start Levee Mile	0.22
End Levee Mile	0.22
Location	Water Side
Category	Earthen Levee
Item	Encroachments
View of a prunings pile along the waterward bank looking downstream.	
pkazi_f_20131001_562.jpg

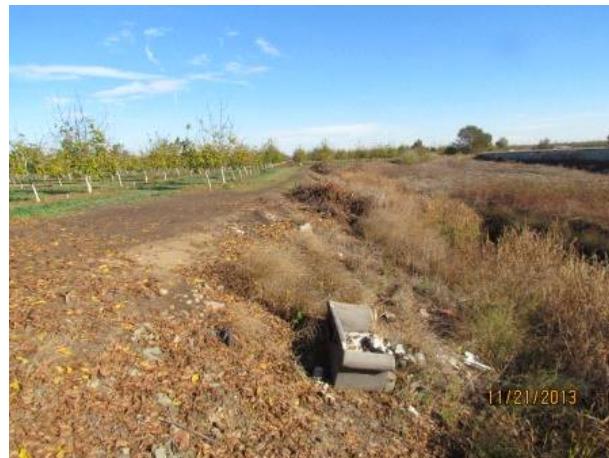
Levee Mile Report Line	5
Start Levee Mile	0.25
End Levee Mile	0.25
Location	Water Side
Category	Earthen Levee
Item	Encroachments
Debris was found on the waterside slope of the levee looking upstream during fall 2013 inspection.	
pkazi_f_20131122_084.JPG

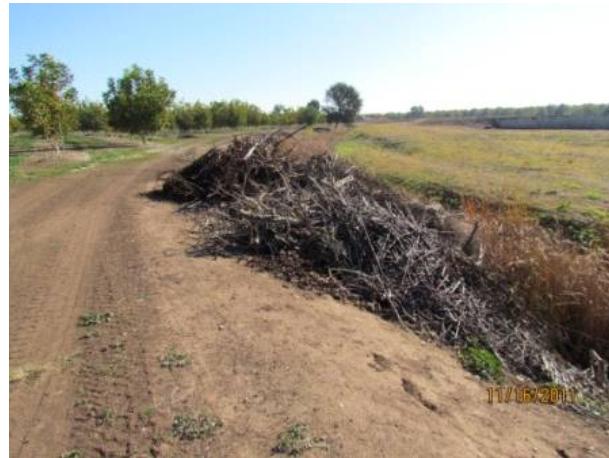
Levee Mile Report Line	6
Start Levee Mile	0.25
End Levee Mile	0.25
Location	Water Side
Category	Earthen Levee
Item	Encroachments
Prunings were found on the waterside of the levee looking upstream.	
pkazi_f_20131001_563.jpg

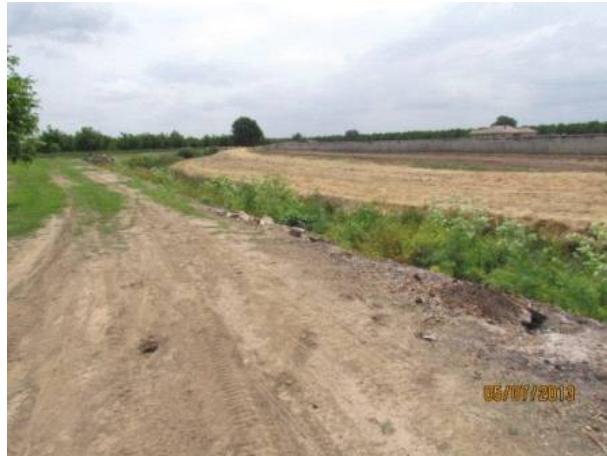
Levee Mile Report Line	7
Start Levee Mile	0.27
End Levee Mile	0.27
Location	Water Side
Category	Earthen Levee
Item	Encroachments
Pruning pile was removed by the farmer on the waterside shoulder of the levee looking upstream.	
pkazi_f_20131001_565.JPG

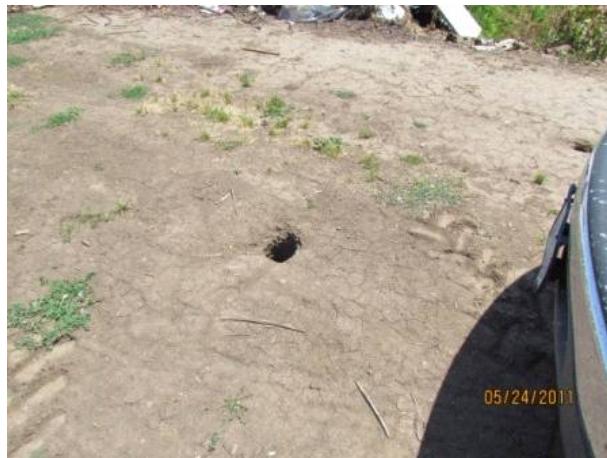
Levee Mile Report Line	8
Start Levee Mile	0.28
End Levee Mile	0.28
Location	Crown
Category	Earthen Levee
Item	Animal Control
A rodent hole was found on the crown of the levee. The picture was taken from the crown looking upstream.	
pkazi_f_20131001_564.jpg

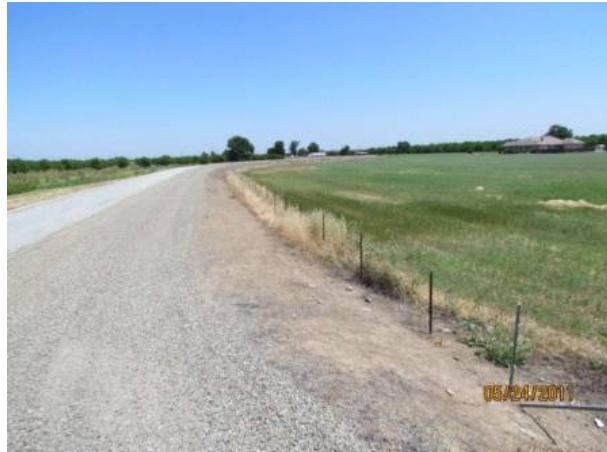
Levee Mile Report Line	1
Start Levee Mile	0.08
End Levee Mile	0.29
Location	Land Side
Category	Earthen Levee
Item	Encroachments
Fences along the landside toe of the levee. The picture was taken from the crown looking upstream.	pkazi_f_20131001_567.jpg

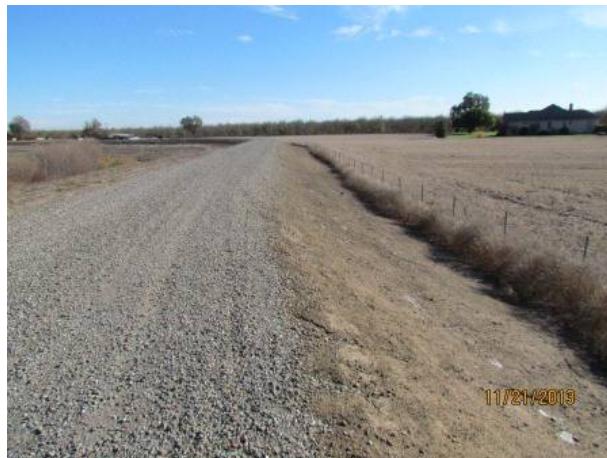
Levee Mile Report Line	2
Start Levee Mile	0.20
End Levee Mile	0.20
Location	Land Side
Category	Earthen Levee
Item	Vegetation
View of the landside of the levee looking upstream.	pkazi_f_20131122_085.JPG
